Manhole Inspection Summary

Manhole # S41SS_020MH

Insp Date: **2/20/07 9:14 AM**

Location Address: **2525 CECIL AVE**

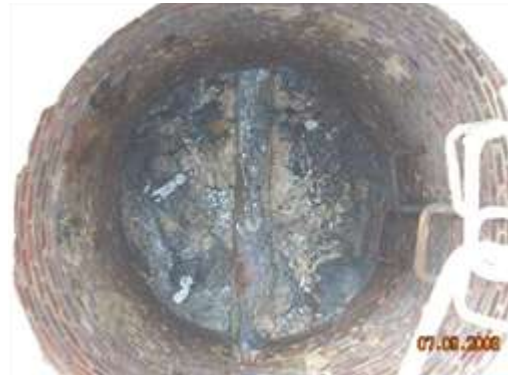
Top View

Corroded steps. Evidence of surcharge - Bench debris. Channel debris.

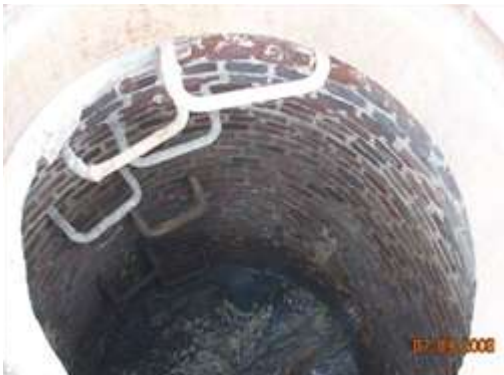
Defect

Frame leaks. Frame offset. Adjustment deterioration and infiltration. Barrel infiltration - other side.

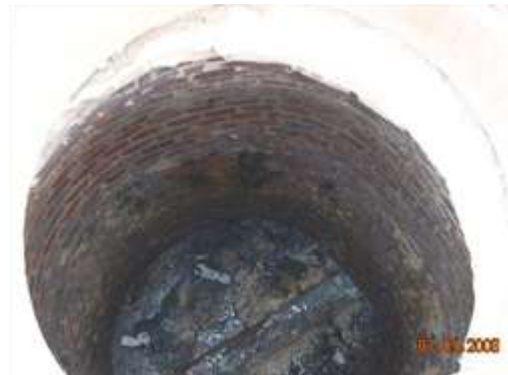
Defect

Frame leaks. Frame offset. Adjustment deterioration and infiltration. Barrel infiltration.

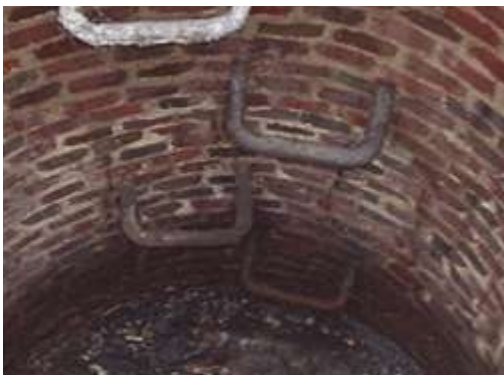
Defect

Corroded steps. Evidence of surcharge - Bench debris.

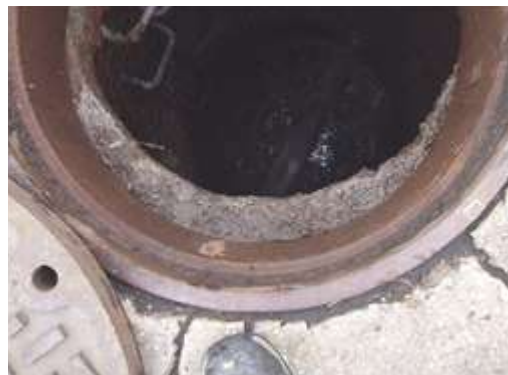
Defect

Frame leaks. Frame offset. Adjustment infiltration.

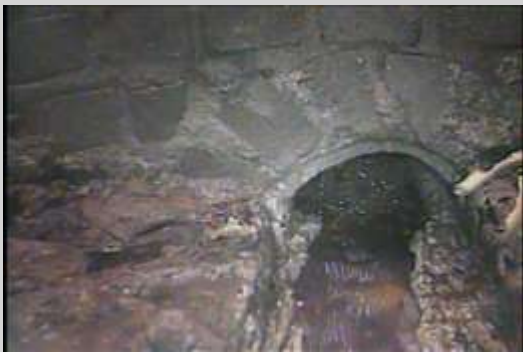
8 in. Circular Gravity Sewer Pipe Out @ 12 O'Clock

Invert Depth: **11.18** (ft.) Flow Characteristics: **Slow**

Deposits: ☐ None ☐ Mud ☐ Sludge ☐ Debris ☒ Grease

Silt Depth: **0** (in.) Deposits Extent: **Medium**

Infiltration: **Evidence** Pipe Seal Cond: **Unknown**

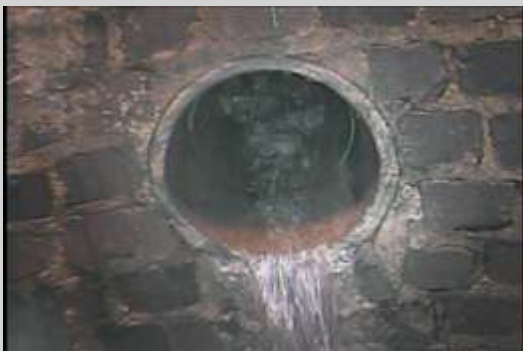
8 in. Circular Gravity Sewer Pipe In @ 6 O'Clock

Invert Depth: **9.13** (ft.) Flow Characteristics: **Slow**

Deposits: ☐ None ☐ Mud ☐ Sludge ☒ Debris ☒ Grease

Silt Depth: **0** (in.) Deposits Extent: **Heavy**

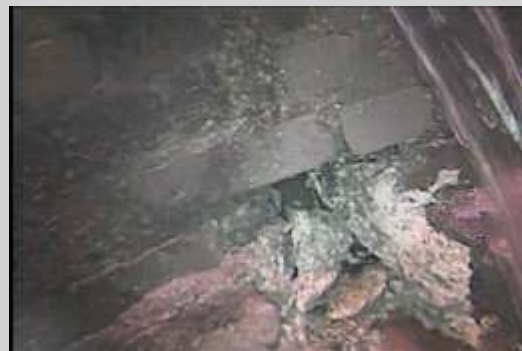
Drop In @ 6 O'Clock

Drop: **Outside** Rod and Bar

Drop Condition: **Clogged**
